HOUSATONIC RIVER BASIN  
SALISBURY, CONNECTICUT

# TWIN LAKES DAM CT 00593

PHASE I INSPECTION REPORT  
NATIONAL DAM INSPECTION PROGRAM

Identification No:	CT 00593
Name of Dam:	Twin Lakes Dam
Town:	Salisbury
County and State:	Litchfield, Connecticut
Stream:	Schenob Brook
Date of Inspection:	April 23, 1979

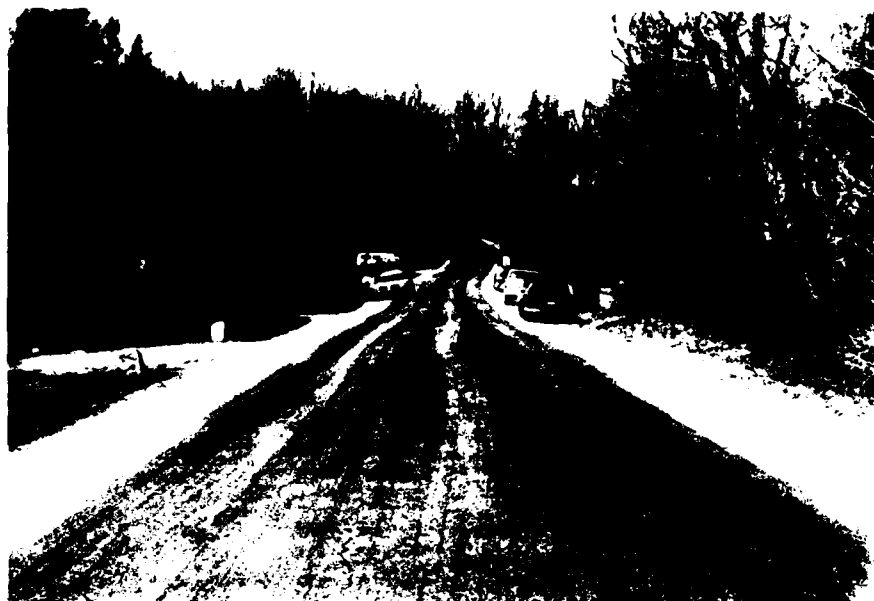
Crest. An asphalt roadway runs the length of the dam crest. (See photo 5). The condition of the pavement is fair to good with some small cracks running parallel to the crest.

A 1 to 4 inch deep dip in the roadway surface was observed in the area of the intake gate structure. This depression extended across the width of the pavement and about 40 feet along the roadway.

PHOTO NO. 5 - From center line of roadway looking towards the right abutment. Cedar trees range from 9 to 13 inch diameter in front of power house. Note dip in roadway adjacent to upstream gate control structure.

- a. The owner should retain the services of a professional engineer to investigate the cause and significance of the dip in the roadway on the crest of the dam in the area of the gate control structure.
- b. All trees and shrubs on the dam embankment should be evaluated as to whether they should remain. If removed, the resulting stump and root voids shall be backfilled with proper material.

- c. The depression in the roadway on the crest of the dam should be monitored regularly to determine if it is increasing in size. Continued subsidence could lead to cracking of the discharge pipes in the embankment which could cause the embankment to fail as a result of piping.

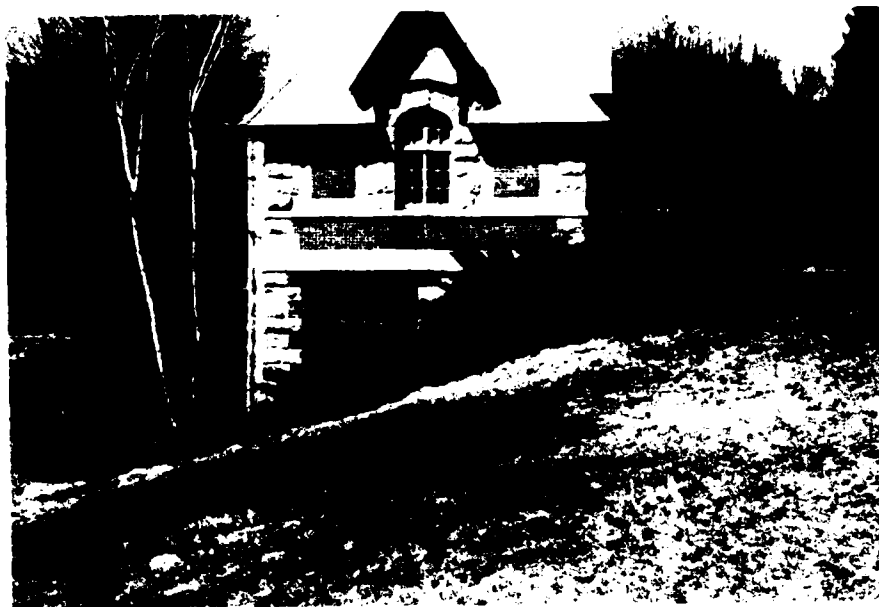
PHOTO NO. 11 - From left side of dam looking along downstream face toward the old powerhouse.
